TECHNICAL NOTE WCLC 53-2

**THE EFFECT OF WATER AND ICE  
ON  
MICROWAVE TRANSMISSION THROUGH RADOMES**

*Charles K. Schramm, Jr., 1st Lt, USAF  
Components and Systems Laboratory*

*February 1953*

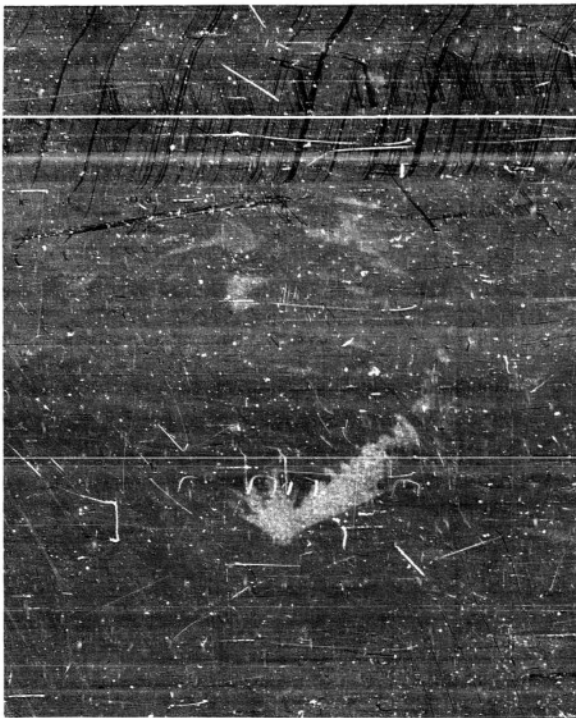
1. 5 mile range on flight line.
2. Same with 1/8" sheet of water on radome.

Photograph SML35642, page 5, was taken while the radome was under test on the ground. A fire hose was used to produce the 1/8-inch thick sheet of water on the surface of the radome. A comparison of the scope picture made under dry conditions with the scope picture taken when the radome had a thick surface water sheet gives evidence of a major reduction in microwave energy transmission through the radome.

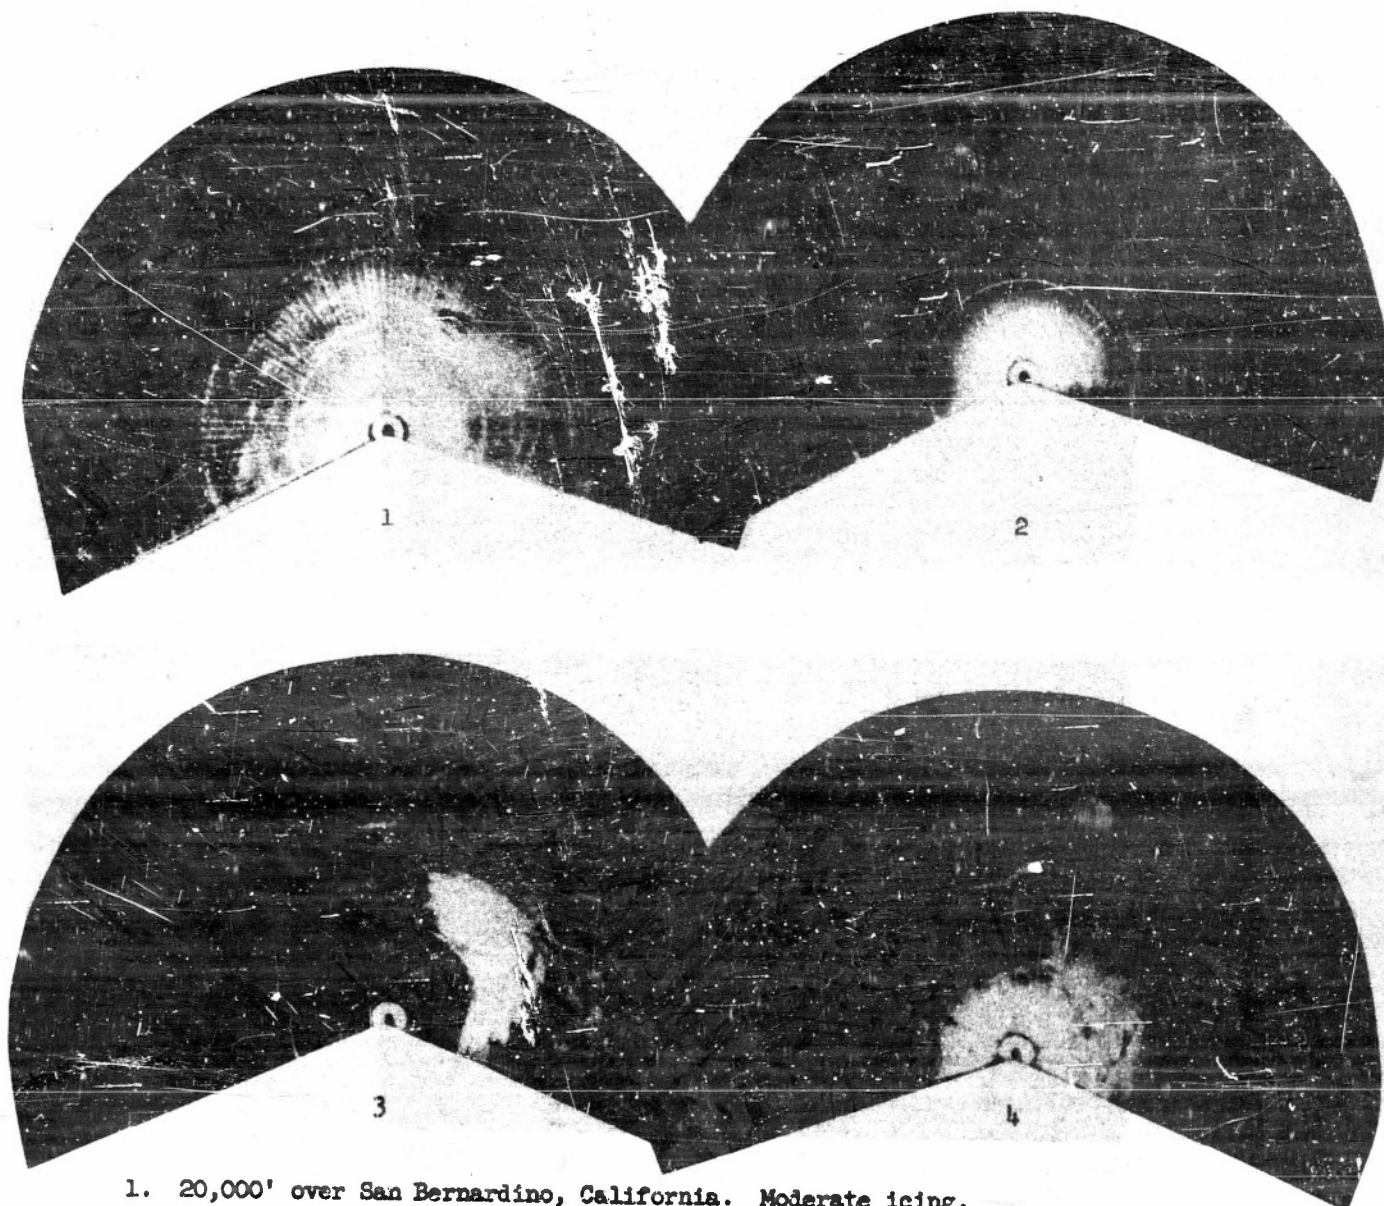
Icing on the C-118

1. 20,000' over San Bernardino, California. Moderate icing.
2. Same location. Radar practically useless due to heavy icing. Notice maximum attenuation ahead due to thicker ice on nose of radome.
3. Heading towards the coast in the clear sunshine. Most of the ice on the left of radome has started to melt, thus attenuating this side more, due to the thin water film. Tilt is  $0^{\circ}$ .
4. Same as above with tilt at  $-5^{\circ}$ . - Seems that more energy gets out of bottom of dome where there is little or no ice.

Finally, Photograph SMI35645, page 7, was taken during flight and under moderate icing conditions on the surface of the radome. While heading towards the coast in the clear sunshine most of the ice on the left side of the radome started to melt, producing a thin film of water on this surface of the radome. These pictures serve to illustrate the relative effects of rain and ice on radar transmission. By comparison of the two pictures, it can be deduced that the presence of a water film on a radome surface produces more serious attenuation of radar transmission than that caused by moderate icing conditions.

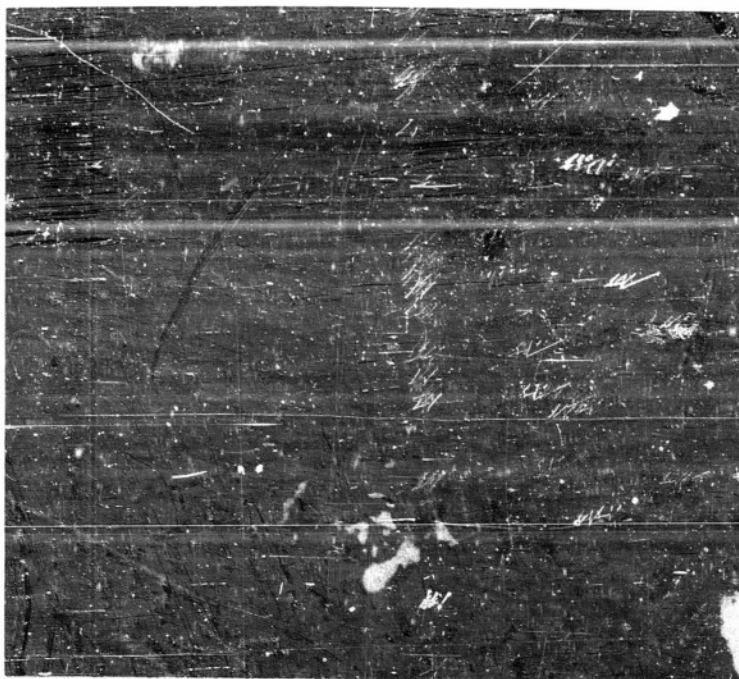
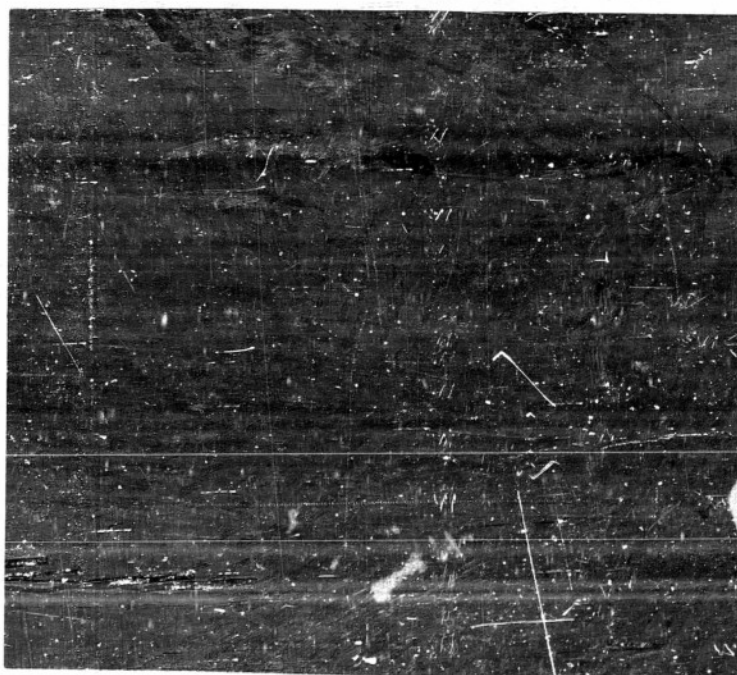
Picture #1 was taken on the flight line with the gain adjusted to show target 12 oclock and 2 miles.

Picture #2 shows the same except that a fine spray is being applied to the radome. The target has disappeared and the range materially reduced.

Photograph SMI35646, page 8, was also taken under ground test conditions. Here, a fine spray was used to wet the surface of the radome. The radar scope pictures indicate evidence of radar degradation even with a light water film present on the surface of the radome.
